# Manhole Inspection Summary

Manhole # S43A2\_002MH

Insp Date: **12/14/07 7:43 AM**

**Location** Address: **3614 West Bay Ave**

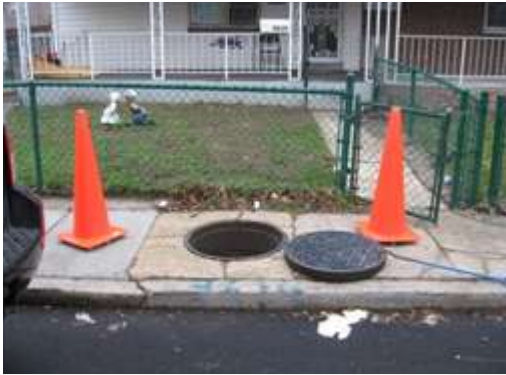
Location View

West Bay Ave.

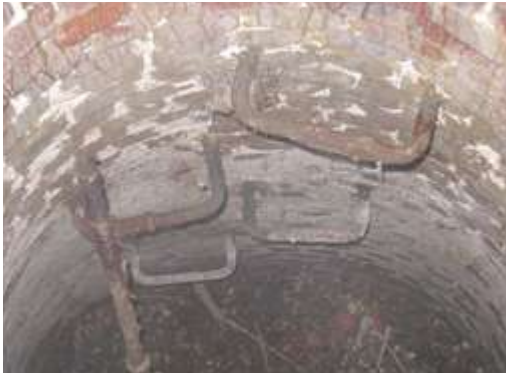
Steps

Count: **4** Missing: **0** ☐ Corroded

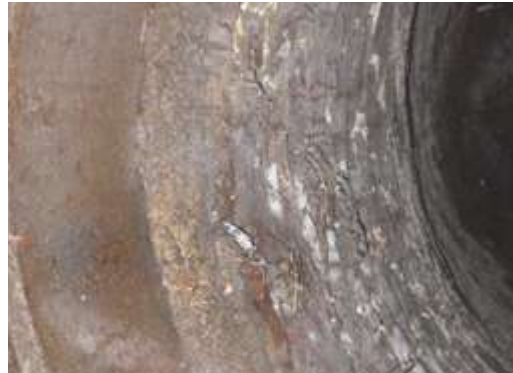
Defect 2

Offset: **1.5** (in.)

Frame offset

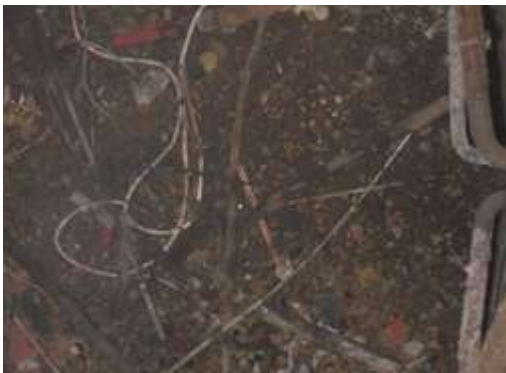
Defect 1

Debris

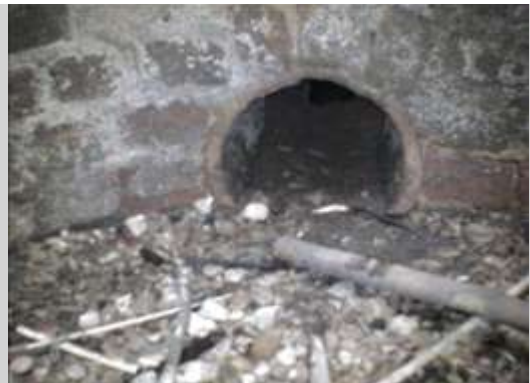
12 O'Clock Outflow

8 in. Circular Gravity Sewer  
Pipe Out @ 12 O'Clock

Pipe Height: **8.4** (in.) Rod and Bar (Angled)

Pipe Material: **Clay** ☐ Pipe Lined

Invert Depth: **8.62** (ft.) Flow Characteristics: **None**

Infiltration: **None** Pipe Seal Cond: **Sound**
